In-Situ Stress Measurements and Instrumentation Installation Duke Energy Walters Dam, Waynesville, North Carolina

Abstract--

This paper serves as a case study for the application of current overcoring stress measurement methods for the structural investigation at an operating United States Federal Energy Regulatory Commission (FERC) dam. Drilling and testing were performed at Walters Dam to characterize the structural effects of concrete growth due to Alkali Aggregate Reaction. The project owner, Duke Energy Carolinas, LLC, engaged HDR, Inc. and Agapito Associates, Inc. to perform drilling and testing on-site for later development of a nonlinear, finite-element model by HDR. In 2016–17, AAI performed concrete and bedrock core drilling, in-situ stress measurements, installed permanent monitoring instruments, and collected baseline instrument readings and concrete samples for lab analysis.

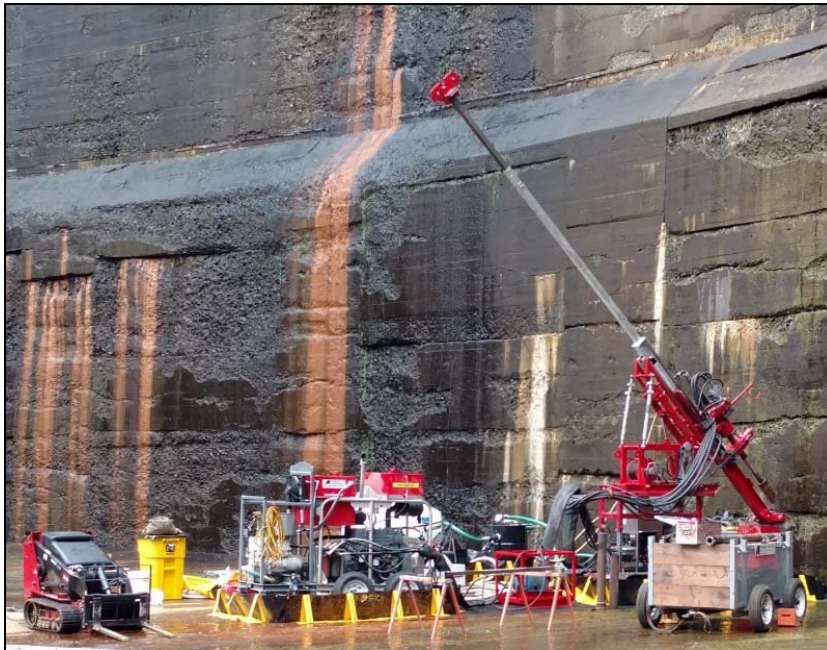
Figure 2. AAI diesel/hydraulic Ingetrol 75E drill rig at the toe of Walters Dam.

AAI completed the field work at the dam between November 3, 2016 and April 20, 2017. AAI's diesel/hydraulic Ingetrol 75E drill rig was used for coring/overcoring work on-site (Figure 2). The work was performed by five AAI personnel. A two- or three-man AAI crew worked one shift per day at the dam during the project. The project took 103 shifts, averaging approximately 12 hours per day.

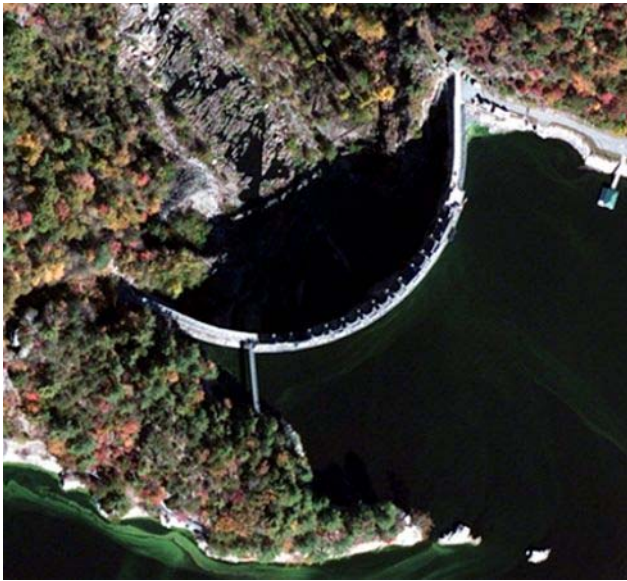
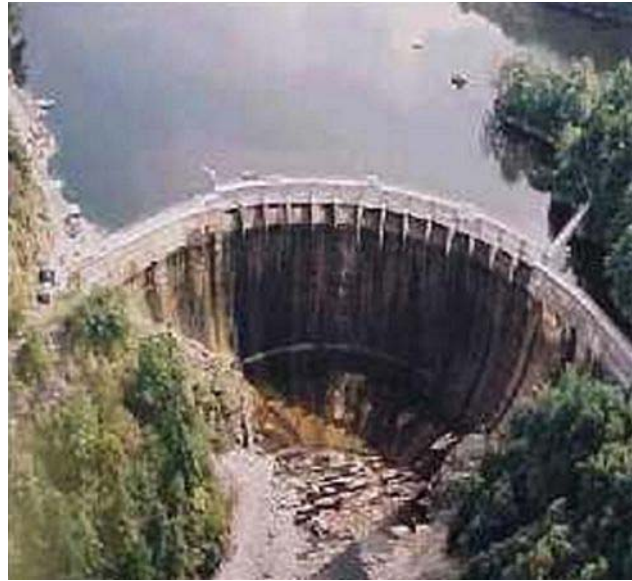
Figure 4. Aerial photographs of Walters Dam.

The Walters Dam is a variable-radius concrete arch structure with a maximum height of 192 ft (58.5 m), a crest length of 900 ft (274.3 m), and a thickness at the base of 41 ft (12.5 m). Photographs of the dam and equipment accesses are shown in Figure 4. The minimum arch thickness is 16 ft (4.9 m) under the spillway ogee and 22 ft (6.7 m) at the spillway. The spillway is controlled by 14 radial gates, each 24 ft (7.3 m) wide and 10 ft (3.0 m) high. The dam was constructed using mass concrete with the diameter of site-sourced aggregate typically ranging from 2 to 4 inches (50 to 100 mm). The dam foundation consists of fresh rock with a base elevation in the central portion of the dam at 2,070 ft (630.9 m). The fresh rock foundation material is metamorphosed feldspatic quartzite and arkose with sparsely occurring thin lenses of dark-colored metasiltstone.

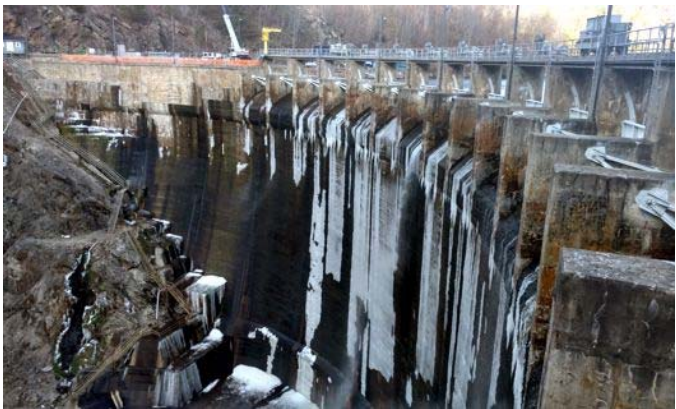
Figure 5. Accessing the drillholes using cranes.

The drilling equipment was mobilized to the dam via cranes (Figure 5) and floating barges (Figure 6) from the upstream side of the dam. Drillholes on the right side of the dam were accessed with skids and rubber-tired equipment. Access to the left side of the dam was from a barge and crane. Access to the toe of the dam was via a crane from the dam crest (Figure 7). When working at the toe, personnel access was via a metal stairway located on the downstream right abutment.

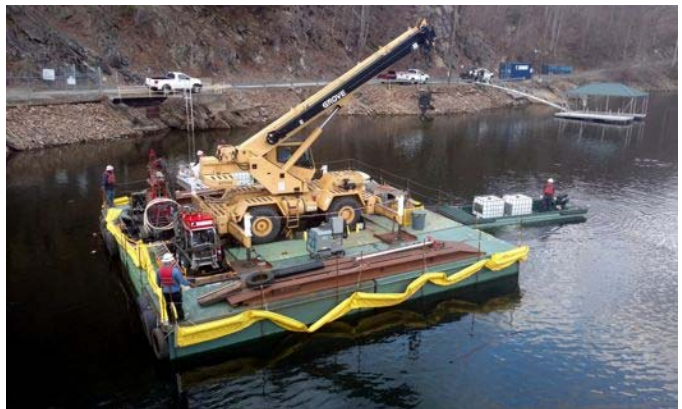
Figure 6. Access the drillholes using barges.

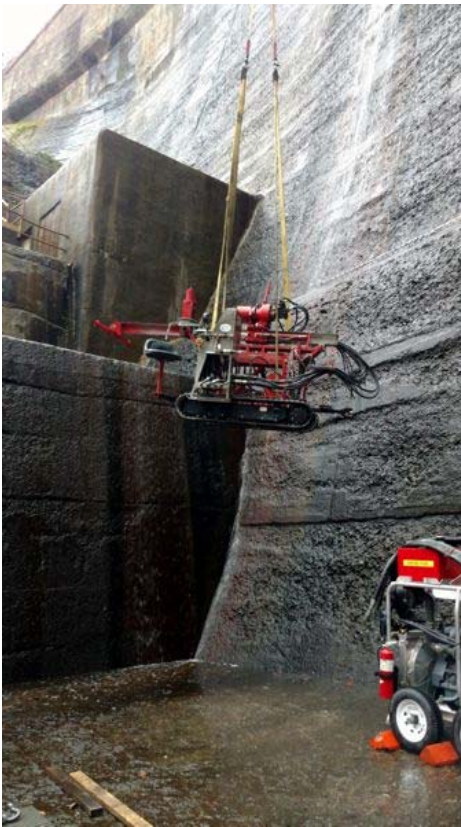
Figure 7. Accessing the toe of the dam using rubber-tired vehicles and cranes from the top.

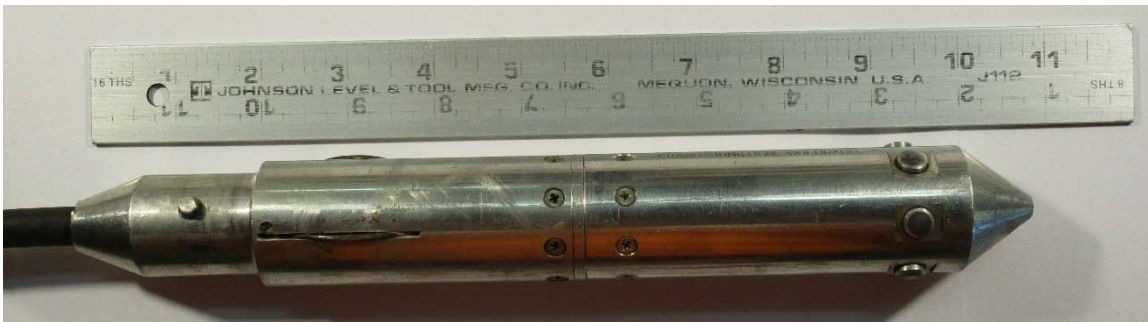
a) USBM BDG gauge

b) Sigra IST gauge

Figure 8. USBM and Sigra gauges used to measure strains in the core during overcoring.

The USBM and Sigra gauges measure the 2D strains in a plane orthogonal to the axis of the gauge. The HI Cell is glued in-place and measures the 3D strains at the location of the gauge. Using the strains and physical properties of the core, the 2D (USBM and Sigra) and 3D (HI Cell) stress tensors can be calculated. Figure 8 shows photos of the USBM and Sigra gauges. Figure 9a shows a HI Cell prior to installation and Figure 9b depicts a cutaway of a HI Cell glued into the core in which it was overcored with the 6-inch (15.2-cm) thin-walled core bit.

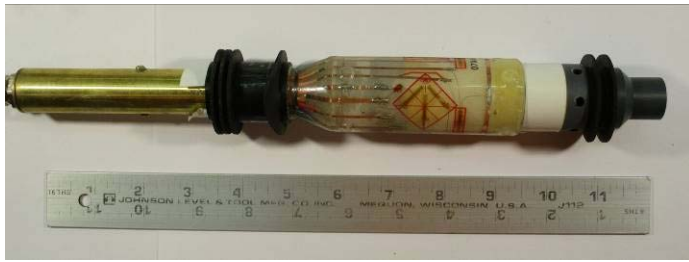
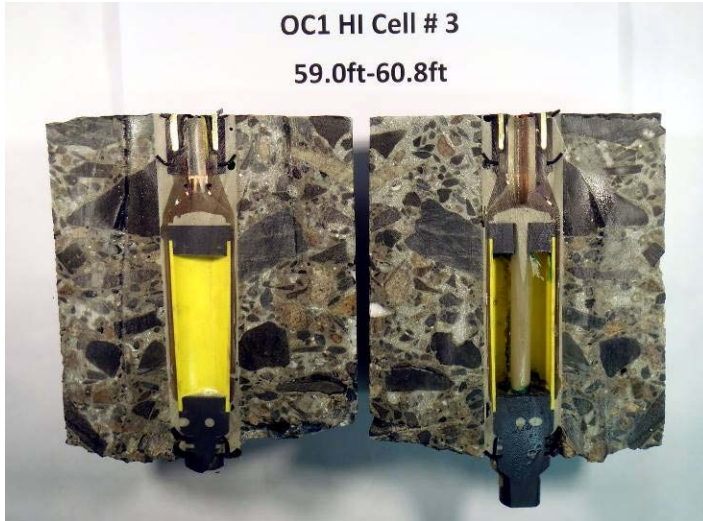
a) HI Cell

b) Cutaway view of HI Cell (glued in place)

Figure 9. Views of HI Cells used to measure 3D strains.

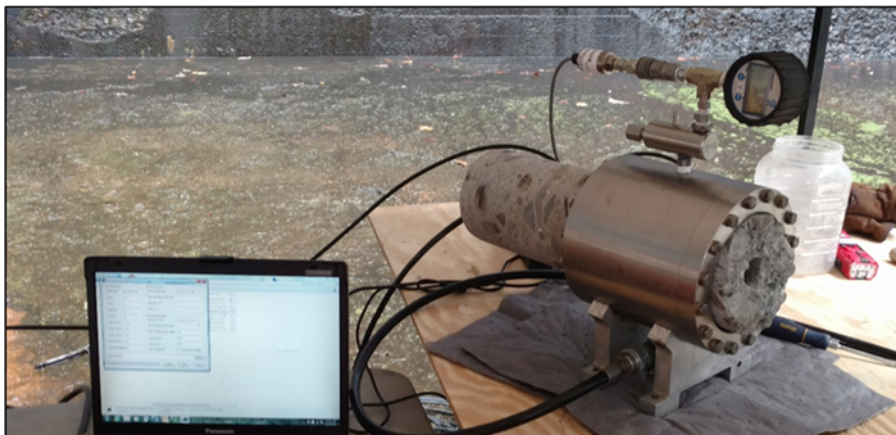
Figure 10. Biaxial test chamber used to determine elastic modulus.

Biaxial tests were conducted on the overcores to determine the Young's modulus of the concrete at each measurement location. Biaxial tests were performed in a specifically designed biaxial chamber (Figure 10) for the 6-inch (15.2-cm) USBM and HI Cell overcores, and in a standard Hoek Cell for the HQ Sigra overcores. Biaxial testing was conducted on-site as soon as the overcores were retrieved from the hole. A total of 70 biaxial tests were performed on-site. Some overcores could not be tested due to defects in the concrete core.

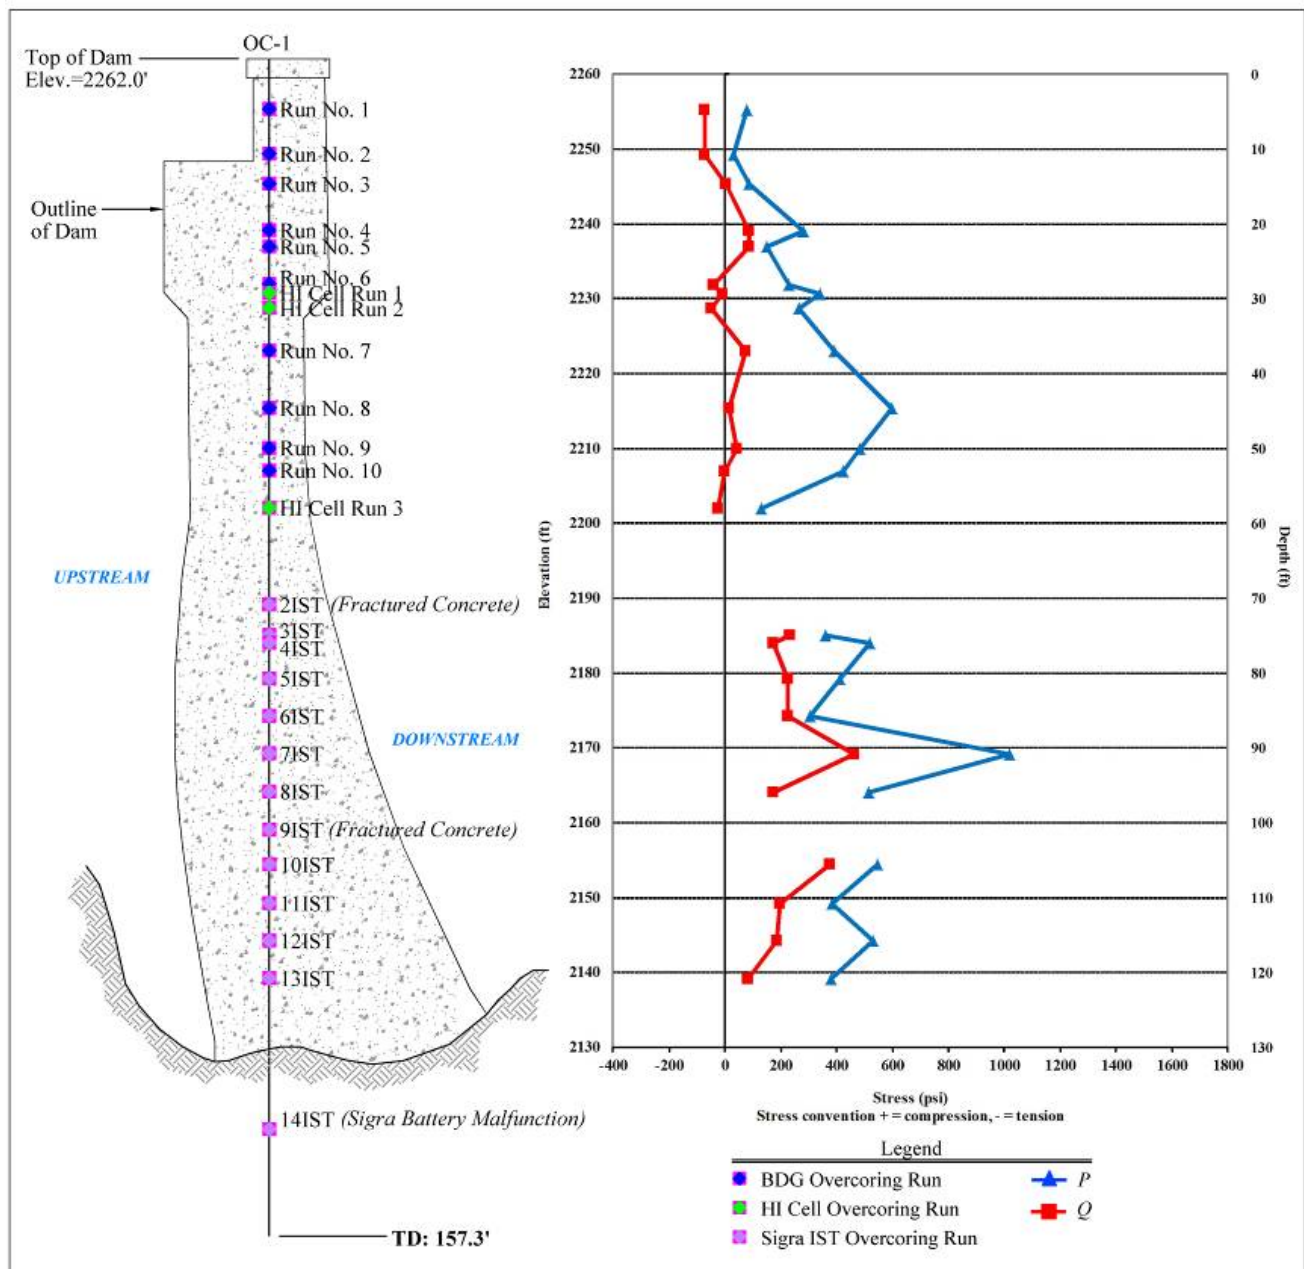
Figure 11. Overcore stress measurement results profiles in Holes OC-1.

Data from the overcoring runs and biaxial tests were collected and transmitted to AAI's Grand Junction, Colorado, office for immediate analysis and verification that the run was acceptable. Communication between HDR, AAI's Grand Junction office, and the on-site overcoring technicians made for efficient decision-making regarding results, hole completion, and hole sequencing. Select stress profiles for OC-1 are shown in Figure 11. The USBM BDG and Sigra results shown in Figure 11 represent the estimated vector magnitude of major principal stress (P) and minor principal stress (Q) on a 2D plane that is orthogonal to instrument axis. The HI Cell results shown in Figure 11.a include the estimated vector magnitude of major principal stress (P) and minor principal stress (Q) in 3D at the instrument depth.

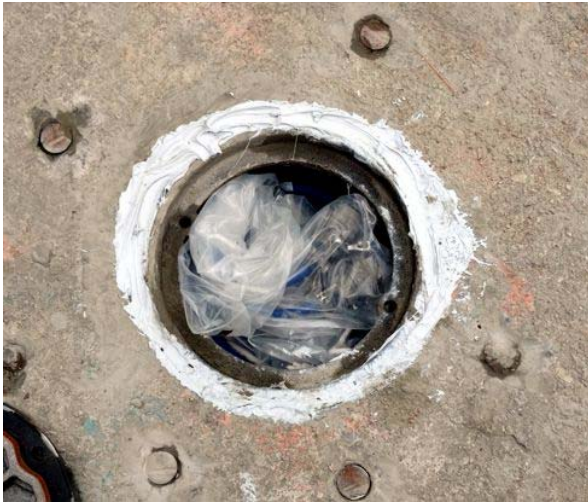
Figure 12. Hole OC-1 temperature probe and flush-mount cover photos.

Completion photos for OC-1 and OC-4 with and without the flush-mount covers are shown in Figures 12 and 13, respectively. The flush-mount covers were grouted into place and then sealed with caulk. The temperature probe connector pins were sealed within a polyethylene wrap to prevent moisture deterioration.

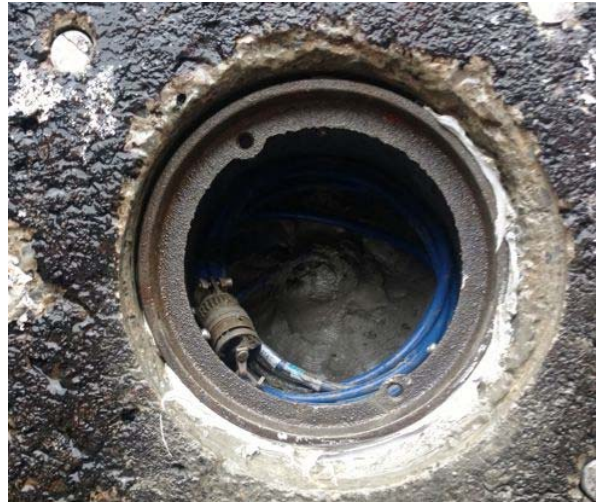
Figure 13. Hole OC-4 temperature probe and flush-mount cover photos.

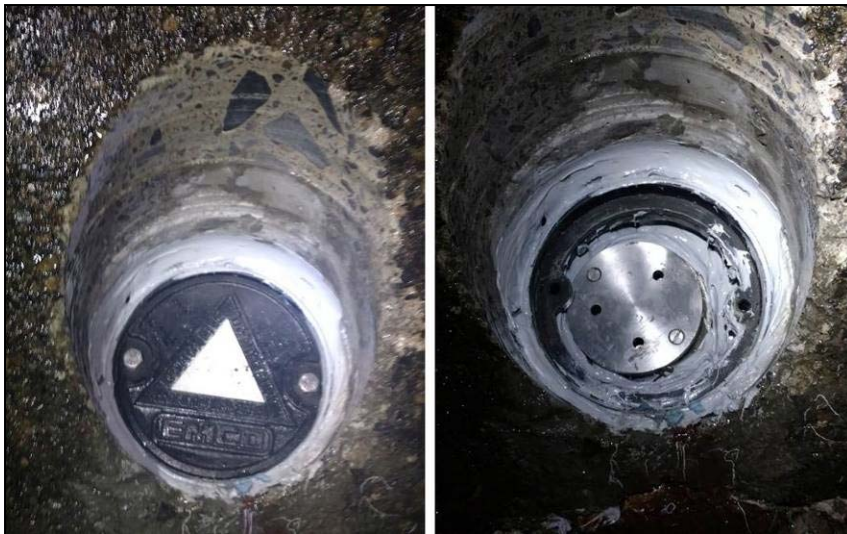
Figure 14. Hole E-1 cover and extensometer photos.

A Geokon Model 1280 A6 Borehole Extensometer was installed and grouted into place in Hole E-1 on the downstream toe, with 0.9-ft (0.27-m) anchors set at 8.3, 20.3, and 34.3 ft (2.5, 6.18, and 10.5 m) (top of anchor) into the 45°-inclined borehole. The interface between the concrete dam and bedrock occurs between 18 (5.5 m) and 19 ft (5.8 m). Table 3 summarizes the initial anchor readings and Table 4 lists the anchor depths.

Completion photos for E-1 with and without the flush-mount covers are included in Figure 14. The flush-mount covers were grouted into place and sealed with caulk.

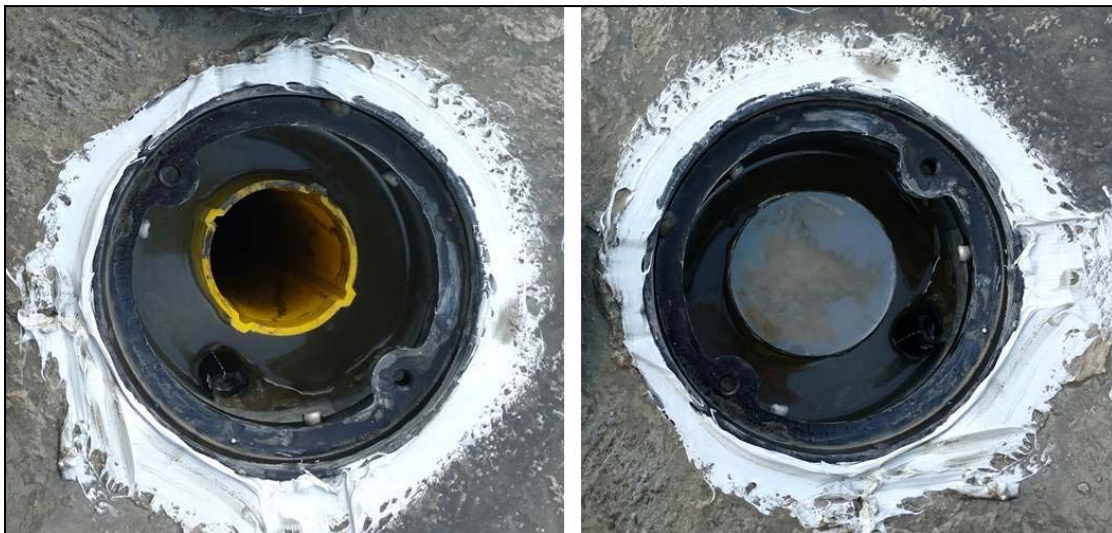
Figure 15. Hole OC-3 inclinometer photos.

Geokon Model 6500 Inclinometer Casing was installed and grouted into OC-2 and OC-3 to depths of 155 ft (47.2 m) and 106 ft (32.3 m), respectively. Both casing installations were inspected with a borehole camera for defects in the casing and casing grooves after installation.

Inspection of OC-3 revealed the casing was compromised between 90 (27.4 m) and 106 ft (32.3 m) deep as a result of grout entering the casing and filling the grooves. AAI successfully cleaned the casing grooves to a depth of 94 ft (28.6 m), and subsequently filled in the bottom portion of the compromised casing to a depth of 87.6 ft (26.7 m) with 78 mesh pea gravel per HDR's recommendation.

Completion photos for OC-3 are presented in Figure 15. Figure 16 depicts recording a baseline measurement with the Geokon 604D.

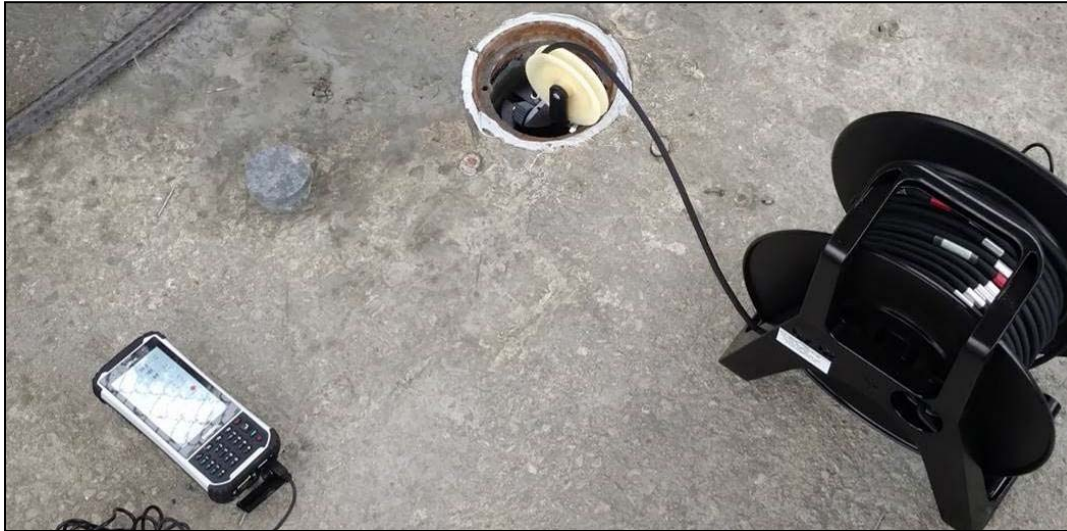
Figure 16. Hole OC-2 inclinometer baseline measurement recording.

A Geokon Model 6000-10E “dummy” inclinometer probe was run in both the A (perpendicular to dam) and B (parallel to dam) axes of each inclinometer casing prior to conducting baseline measurements with the Geokon 604D Digital Inclinometer. The baseline measurements for both the A and B axes were recorded and then processed along with the spiral data in SiteMaster, V4.0.7.3:000, a software product of Deep Excavation (2011).

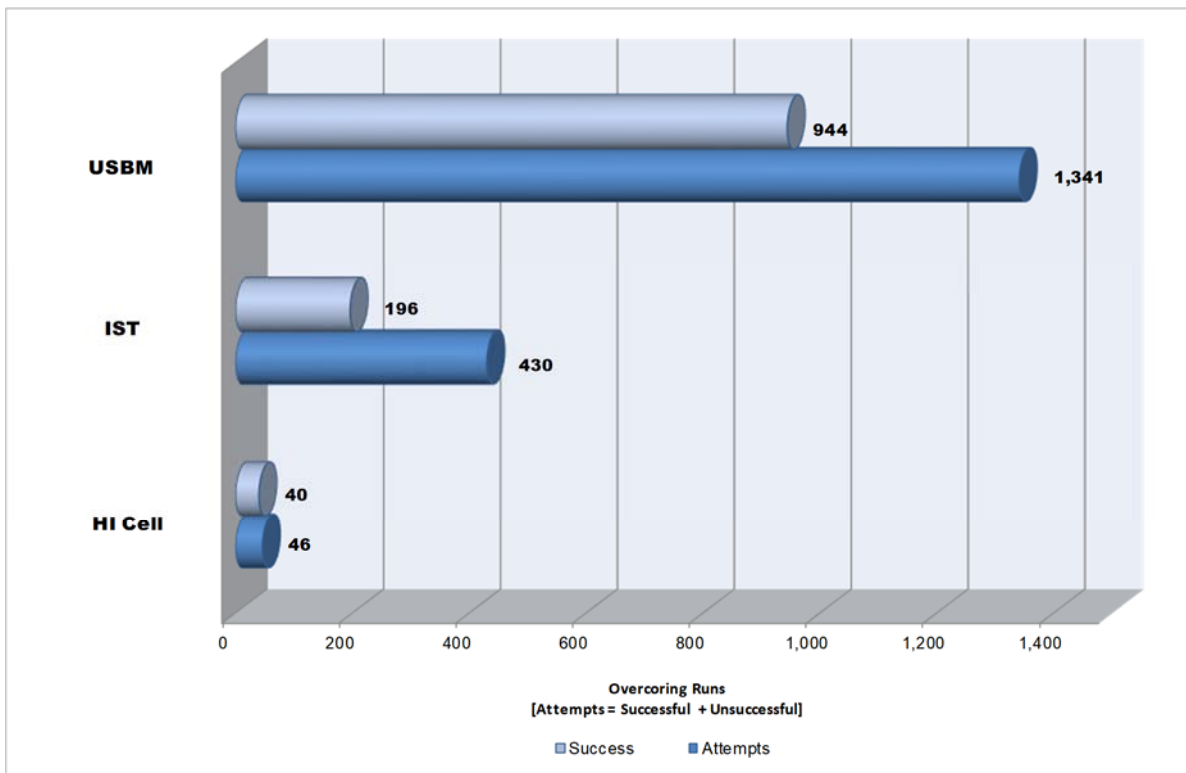
Figure 17. AAI successful versus total attempted runs for the three overcoring methods from 1978 to May 2018.
